Supplementary Materials

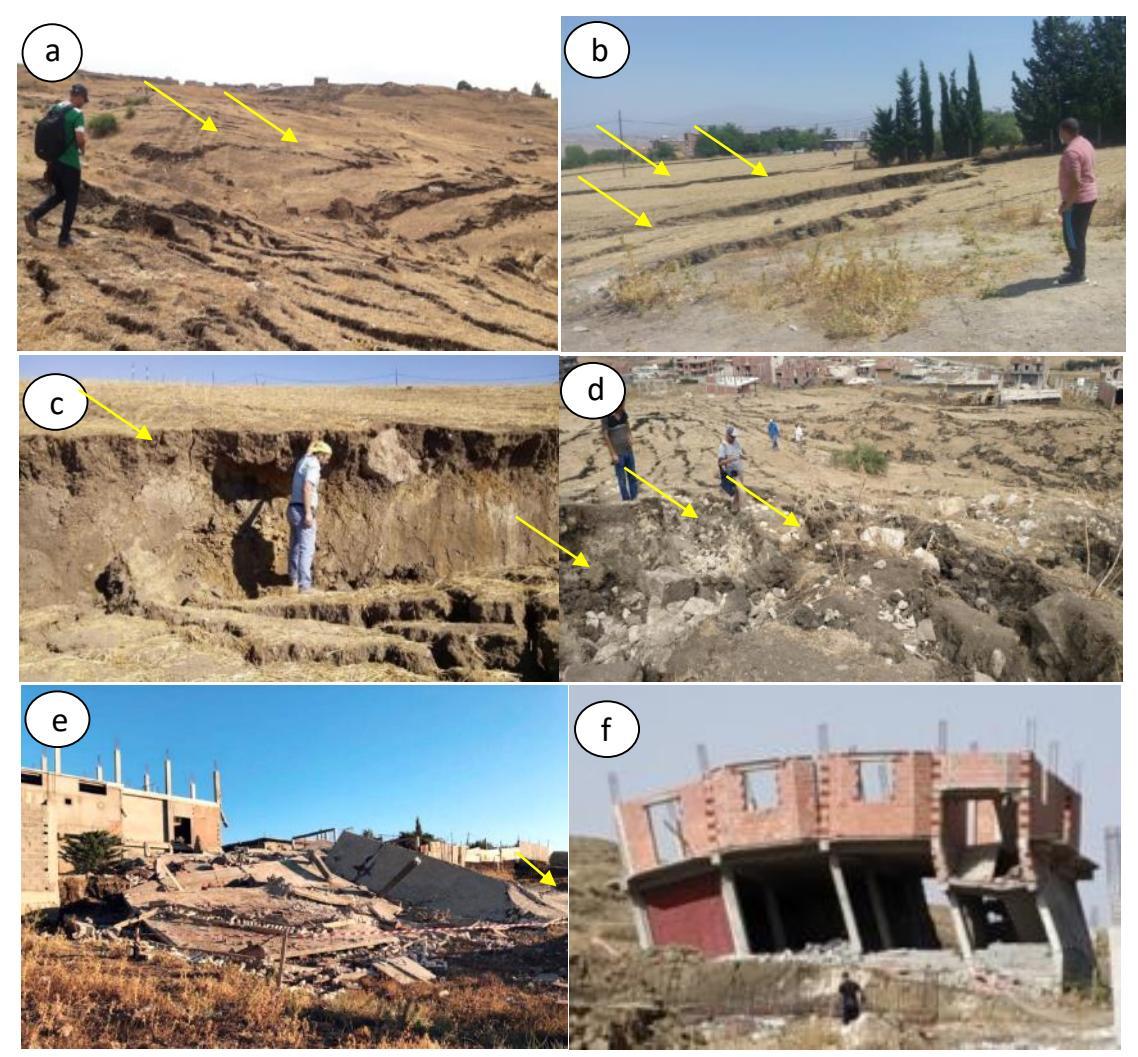
Fig. 1s: Photographs showing different types and forms of mass sliding induced by Mila earthquake in El-Kherba district: a) solifluction lobes in Ain El Kaid city, b)E-W oriented transverse cracks developed upstream of the El-Kherba district, c) lateral tearing niche (escarpment oriented NW-SE of 800 m long and presents a shear plane inclined at 40° to the NE with a horizontal rejection of about 1,7 m) d) ground movement have reaveled Roman ruins at Chaabat Ain El Gaid. e) Total collapsed houses in the lower of El Kherba District due to confluence of 2 tearing niches (2 shear planes) f) Shearing and tiping of a construction due to the upstream soil's thrust.

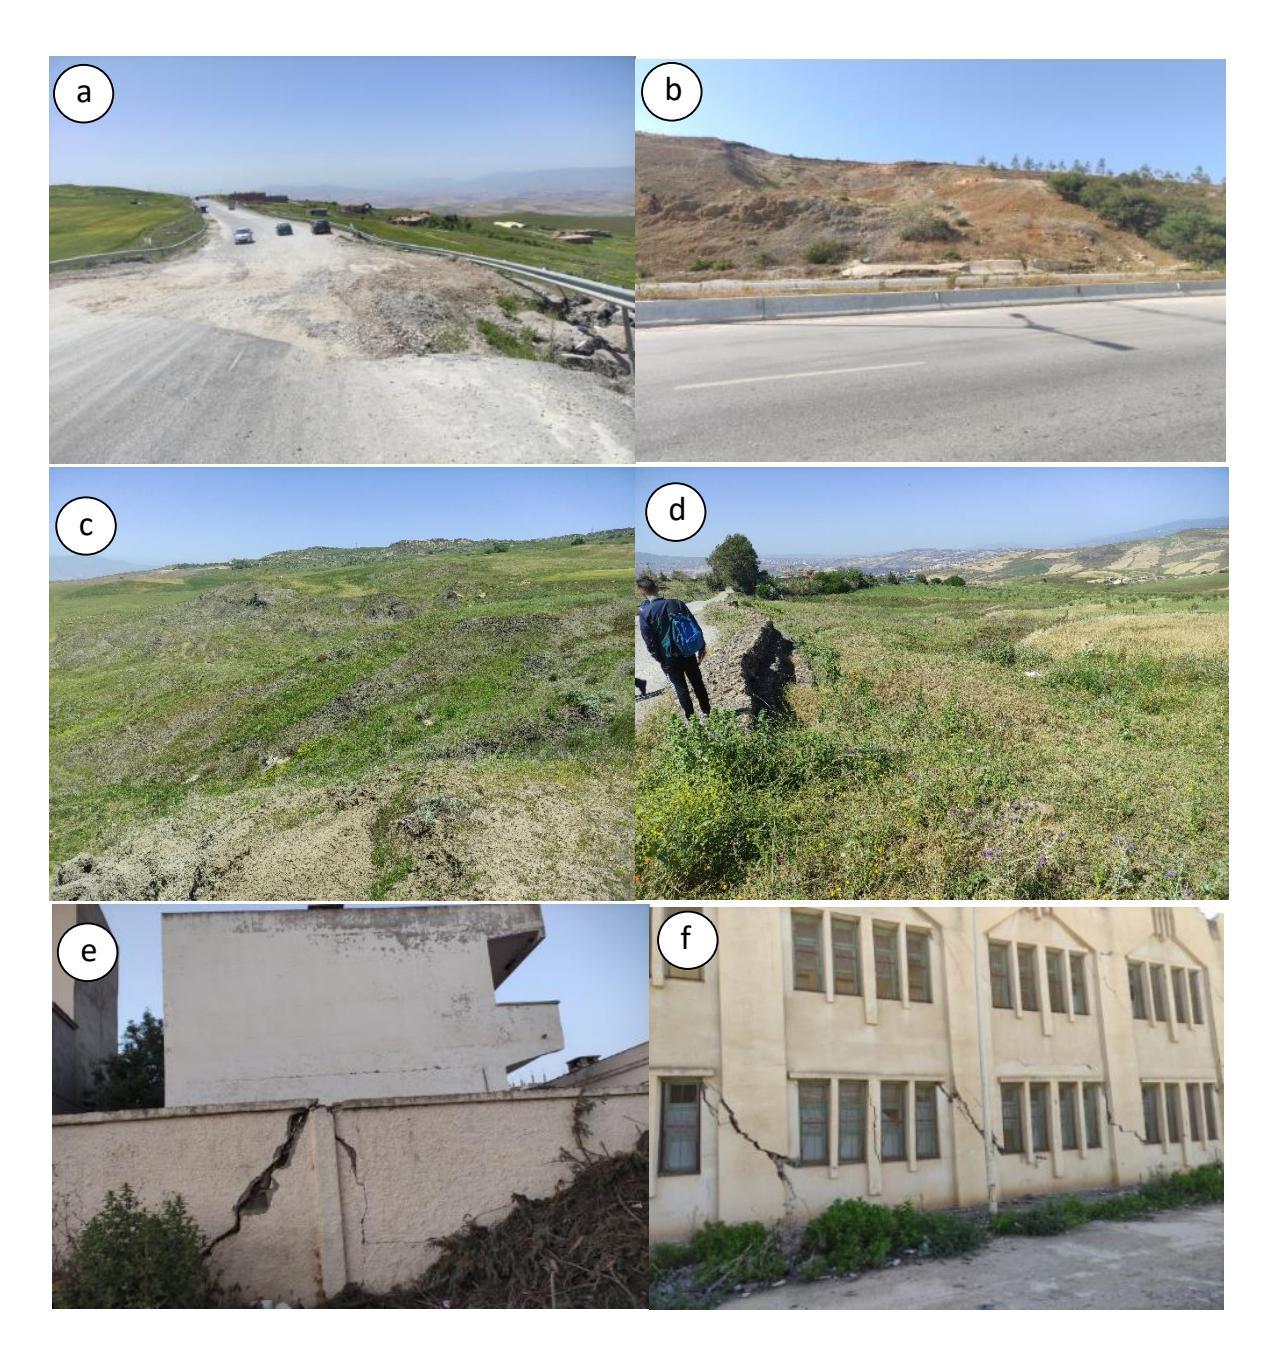
Fig. 2s: Damages occurred at several location in the Mila Basin due to seismically induced landslide: a) and b) landslides affecting some sections of the southern and northern bypass of the city of Mila; c) Sliding at Ouled Bouhallouf valley; d) sliding at Segdal district; e) and f) damage of a primary and secondary school due to local sliding at Grarem city.

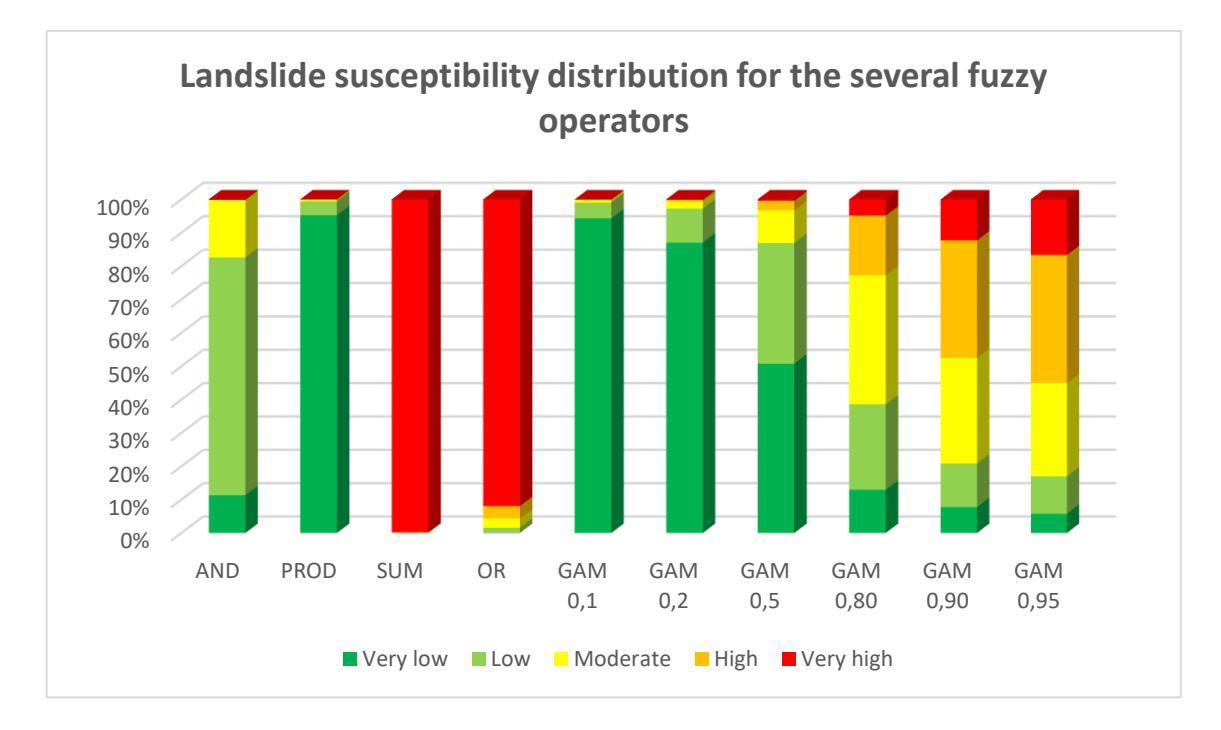
Fig.3s. Landslide susceptibility distribution for the several fuzzy operators

Fuzzy operator	AUC
	score (%)
AND	81.8
OR	94.3
Algebric Sum	96.9
Algebric product	97.1
Gamma operation	
γ=0.1	96.2
γ=0.2	91.3
γ=0.5	77.1
γ=0.8	83.1
γ=0.9	79.9
γ=0.95	82.1
